### **ANNEX B: DRAWINGS**

#### UNHCR DARFUR OPERATION

#### **Tina Hospital**

DRAWING NO **ELF-2021-003**

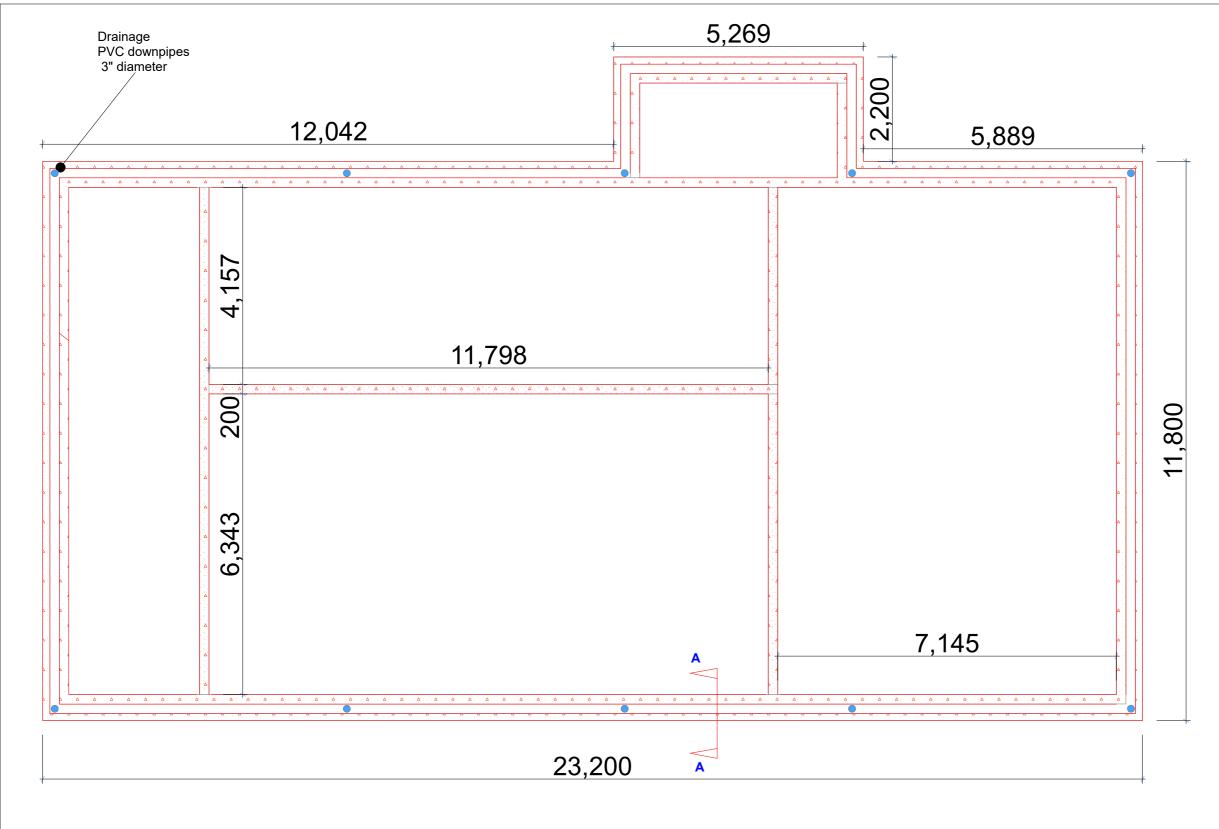
## BEAM/GUTTER LAYOUT (24 BED CAPACITY). BUILDING NO.8

- 1. All dimensions in mm
- 2. Steel surfaces MUST be painted with antirust and three coats of gloss paint
- 3. All concrete works must be cured for a minimum of 7 days

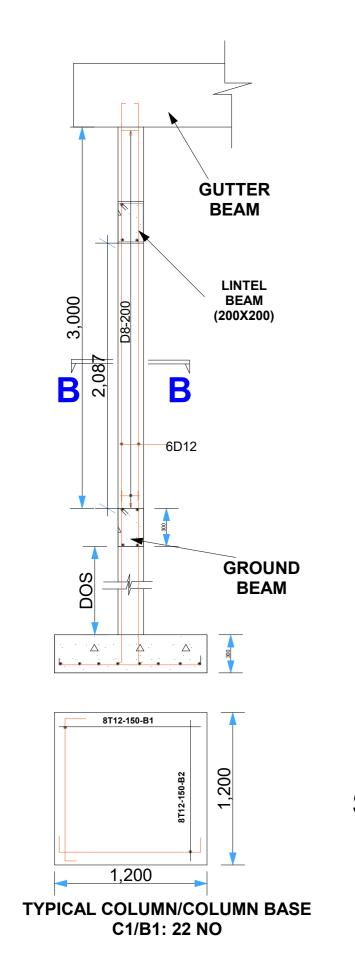
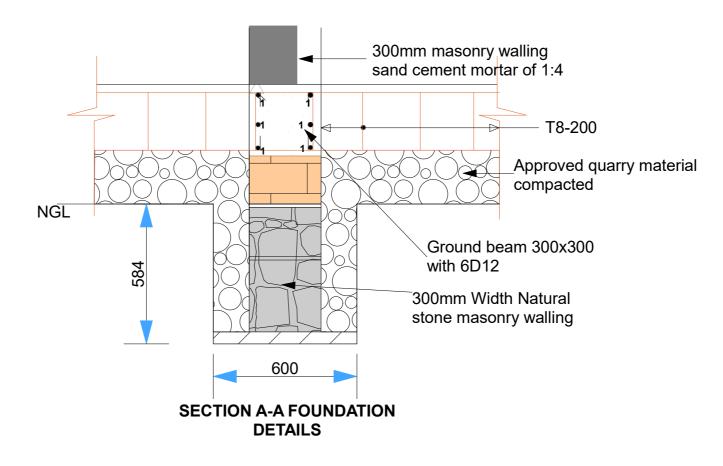
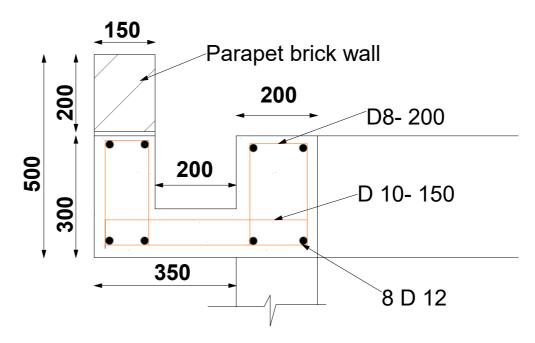
GUTTER BEAM DETAILS. TOTAL LENGTH=72M

- 1. All dimensions in mm
- 2. Steel surfaces MUST be painted with antirust and three coats of gloss paint
- 3. All concrete works must be cured for a minimum of 7 days

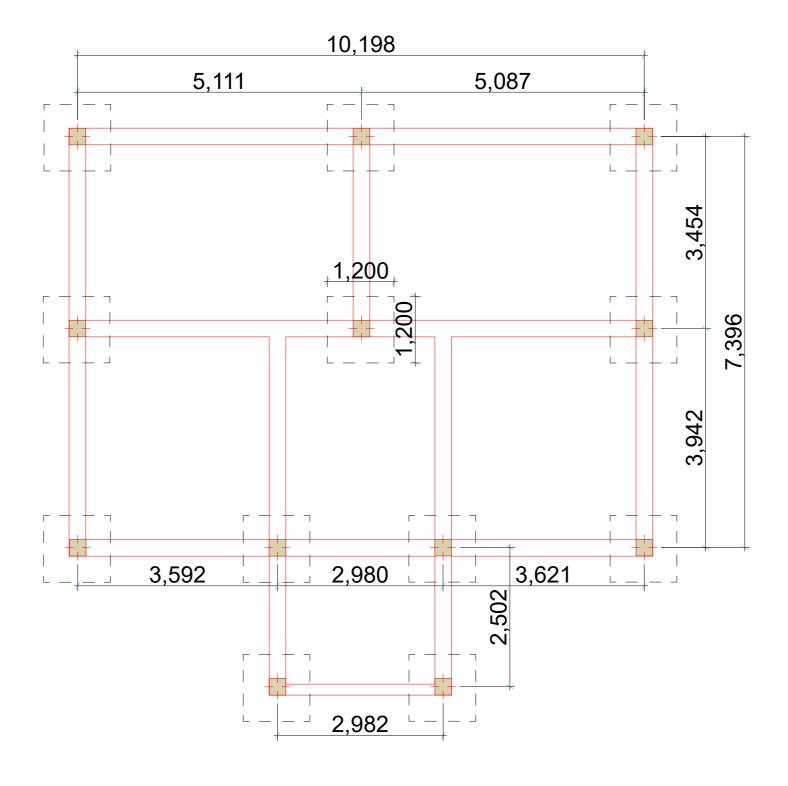
# BLOOD BANK BUILDING FOUNDATION LAYOUT BUILDING NO. 01

- 1. All dimensions in mm
- 2. Steel surfaces MUST be painted with antirust and three coats of gloss paint
- 3. All concrete works must be cured for a minimum of 7 days

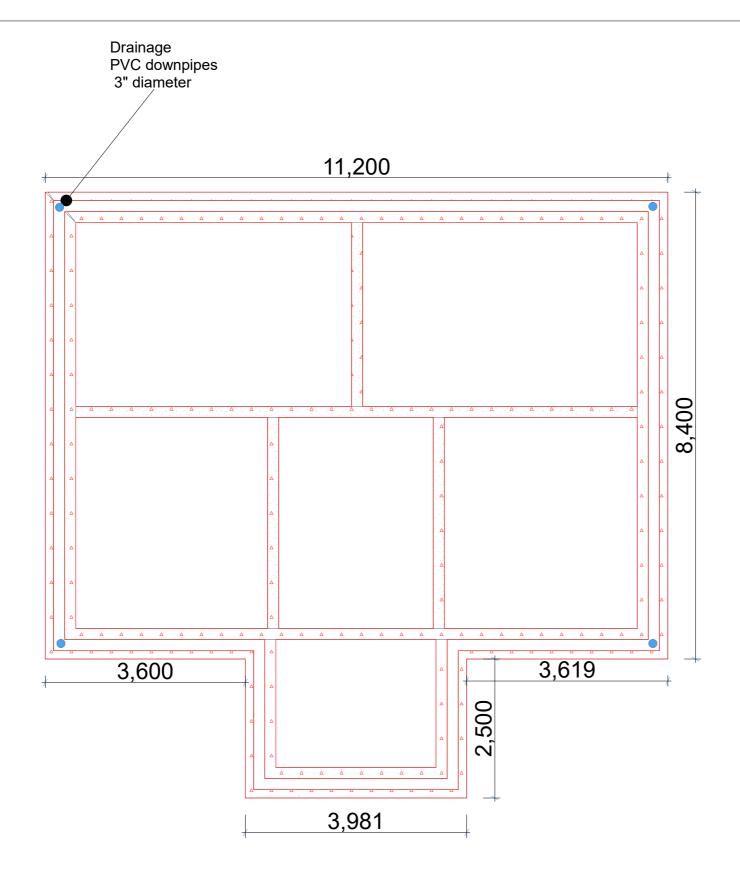
BLOOD BANK BUILDING BEAM/GUTTER LAYOUT BUILDING NO. 01

- 1. All dimensions in mm
- 2. Steel surfaces MUST be painted with antirust and three coats of gloss paint
- 3. All concrete works must be cured for a minimum of 7 days

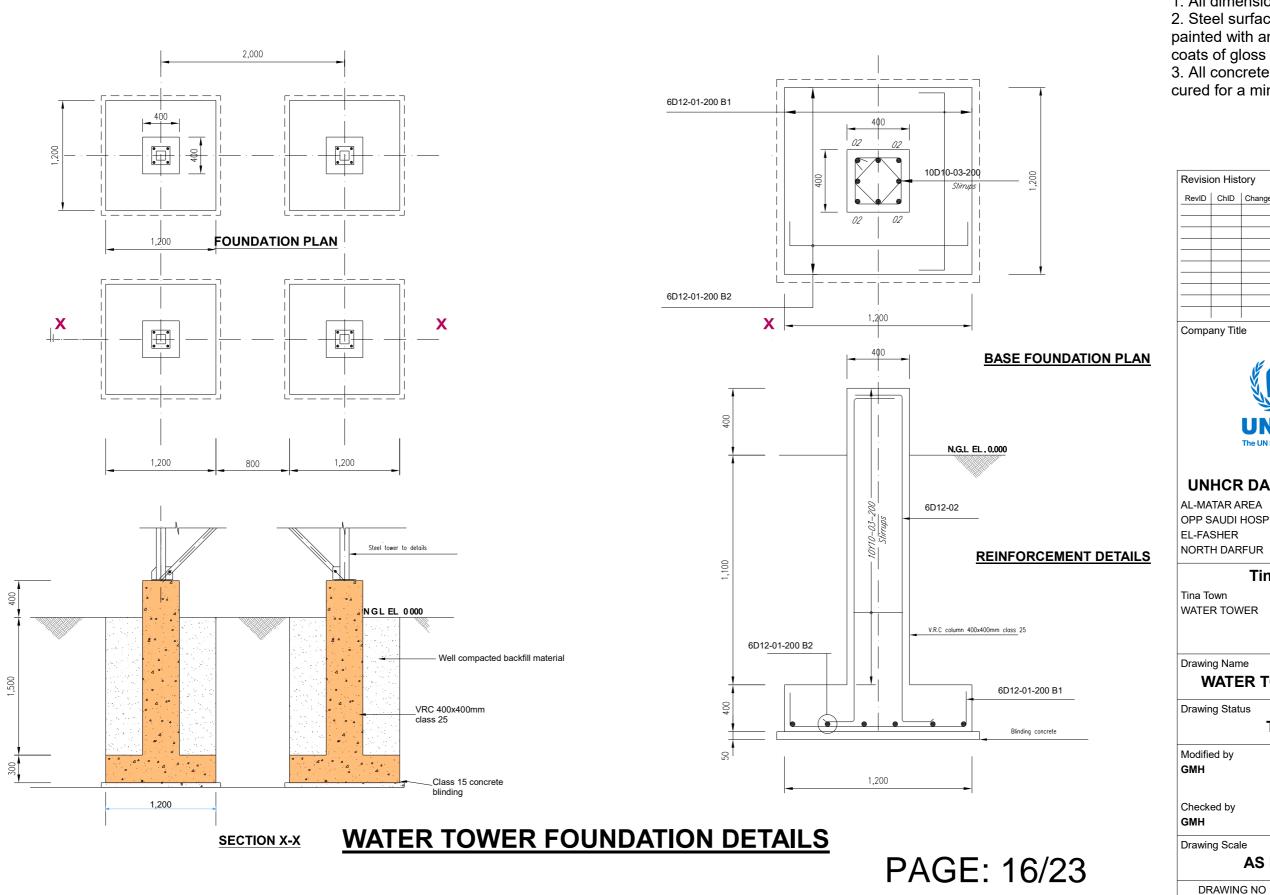
#### WATER TOWER FDN DETAIL\$

- 1. All dimensions in mm
- 2. Steel surfaces MUST be painted with antirust and three coats of gloss paint
- 3. All concrete works must be cured for a minimum of 7 days

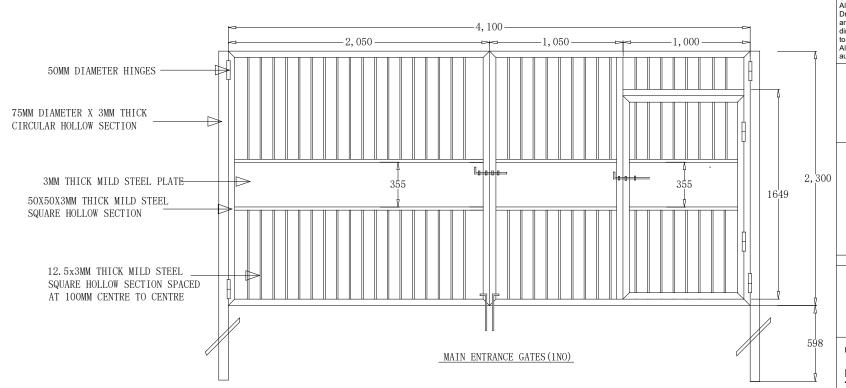
#### MAIN ENTRANCE GATE FOR TINA HOSPITAL

#### PLAN, ELEVATIONS AND SECTION VIEW

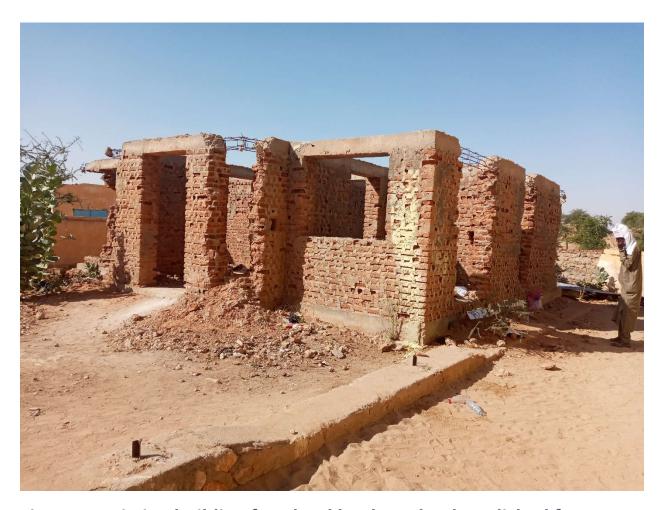
Figure 1. Existing building for Blood bank. To be demolished for a new construction

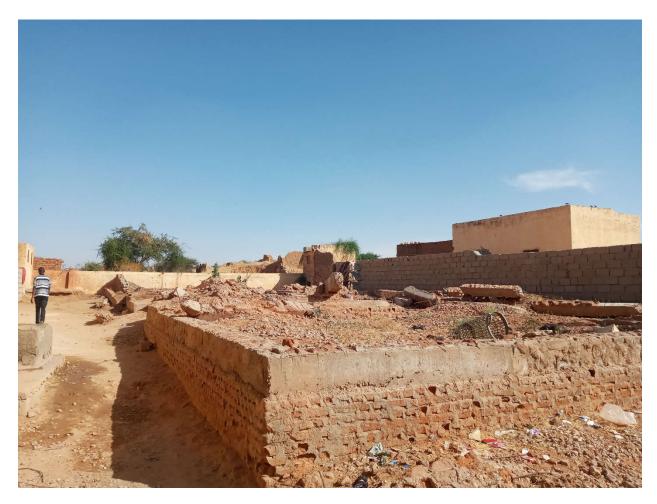
Figure 2. Existing foundation to be demolished for construction of wards as per building no.8

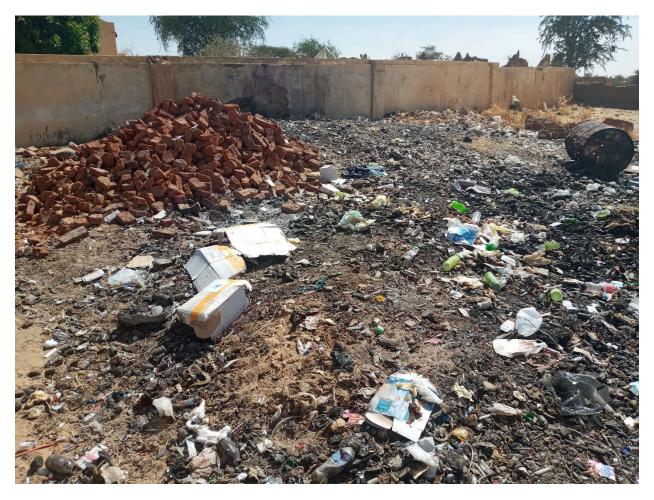
Figure 3. Debris and other waste to be carted away from site

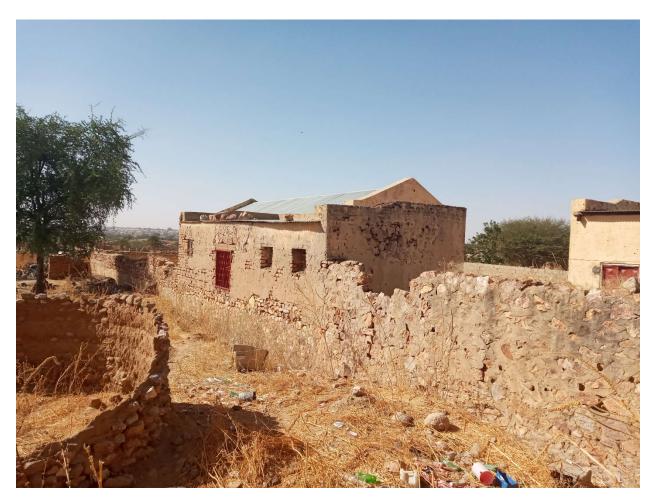
Figure 5. Part of the fence to be repaired
